## Advantest R3132 Local oscillator 3840MHz (2e Mixer) problem

### Problem:

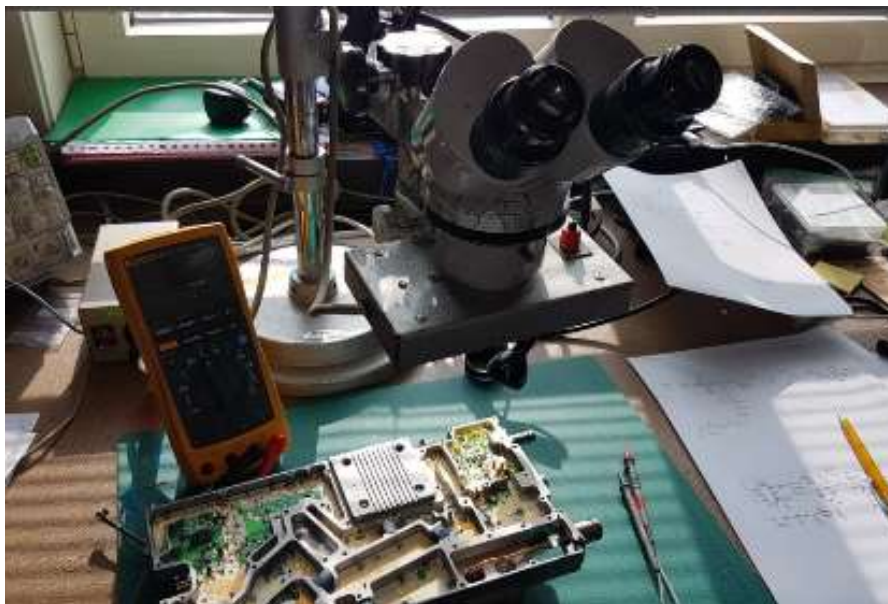
Figure 1 Microscope examination (reverse engineering at work 😊)

It was a lot of work but I managed to do a complete reverse engineering (under a microscope) of this circuit and was able to draw the circuit. The operation of this PLL is quit clever and contained some circuit surprises.

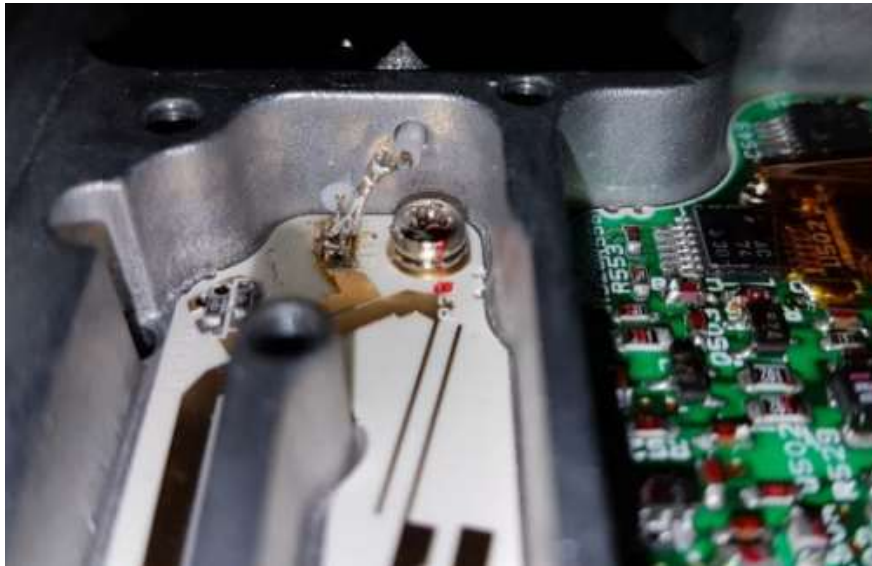
Figure 8: Coax soldered to the stripline

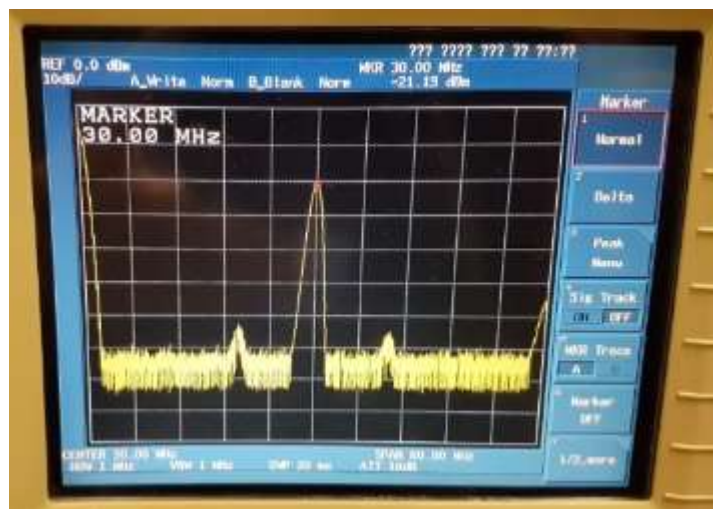
I connected the CALOUT signal to the RF input and monitored the oscillator level and Calibration level during warm-up

Figure 9: CAL value at cold start
